XXXXXXXXXXXXXXXXXXXXX
Inspected Address

1A. Pest Pro Pest Management Services, Inc. 1B. 10555
Name of Inspection Company SPCB Business

5. Main House and Attached Garage Only.

Diagram of Structure(s) Inspected

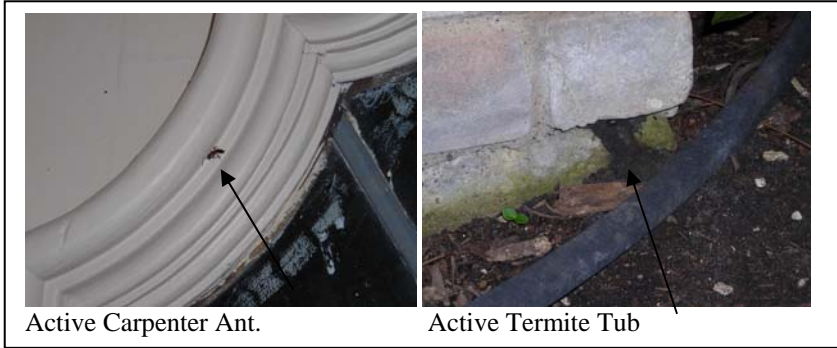
8G. Visible evidence of: Carpenter ants and Subterranean Termites has been observed in the following areas: Carpenter Ants – front porch and Southeast corner of the house. Subterranean Termites – foundation on the North side of the house, the formal dining room, master bathroom, and East hall bathroom.

The inspector must draw a diagram including approximate perimeter measurements and indicate active or previous infestation and type of insect by using the following codes: E- Evidence of Infestation, A-Active; P-Previous; D-Drywood Termites; S-Subterranean Termites; F-Formosan Termites; C-Conductive Conditions; B-Wood Boring Beetles; H-Carpenter Ants; Other(s) - Specify _____

Additional Comments Diagram is not to scale, measurements are approximate.

9B. A preventive treatment and/or correction of conducive conditions as identified in 7A & 7B is recommended as follows: Yes No
 Specify reason: To correct active infestations of Subterranean Termites and Carpenter Ants, and to prevent future infestations.
 Refer to Scope of Inspection Part J
